Troubleshooting

HMI® / HTI® / HSR® / HSD® / VIP® - lamps

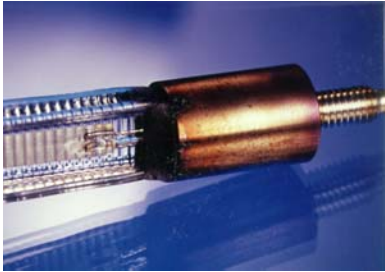
1. Connector base discolored	Connector base overheated above 230°C due to: - Faulty electrical connection - Improper lamp cooling - Improper operating current	Check electrical connections and cooling conditions: - Tighten or replace - Check operating current - Check cooling system (forced or convection)

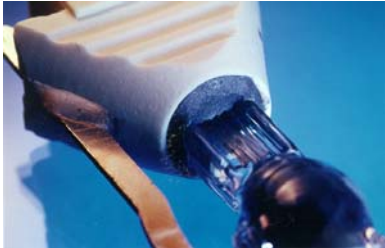
2. Cement blackened, cable tarnished	Connector base overheated; improper lamp cooling	Check electrical connections and cooling conditions

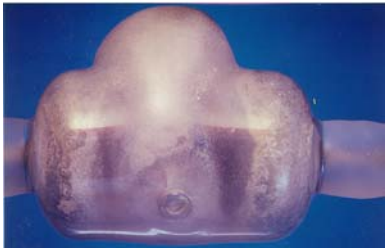
3. Devitrifications and bulb deformation	Aging of the bulb; Lamp has reached or exceeded the nominal life time	Lamp change, replacement

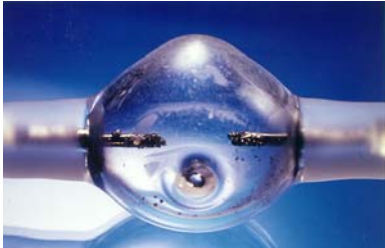
4. Devitrifications and bulb deformation	Burned-in dirt on the outer bulb surface	Before using lamp clean quartz bulb with a lint-free cloth.

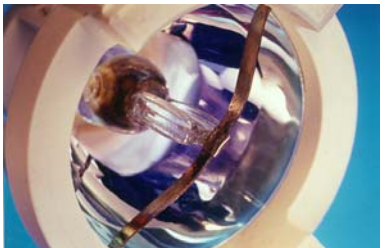
5. Current bar or reflector lamp tarnished	Improper cooling at front side of reflector	Check cooling conditions (forced or convection)
